**Oggetto: Safety Alert riguardante problematiche occorse alle soole dei freni in materiale composito del tipo LL.**

Safety Alert Brake Blocks LL in combination with sliding/fixed brakes.

NSA: Dutch Inspectorate - ILT

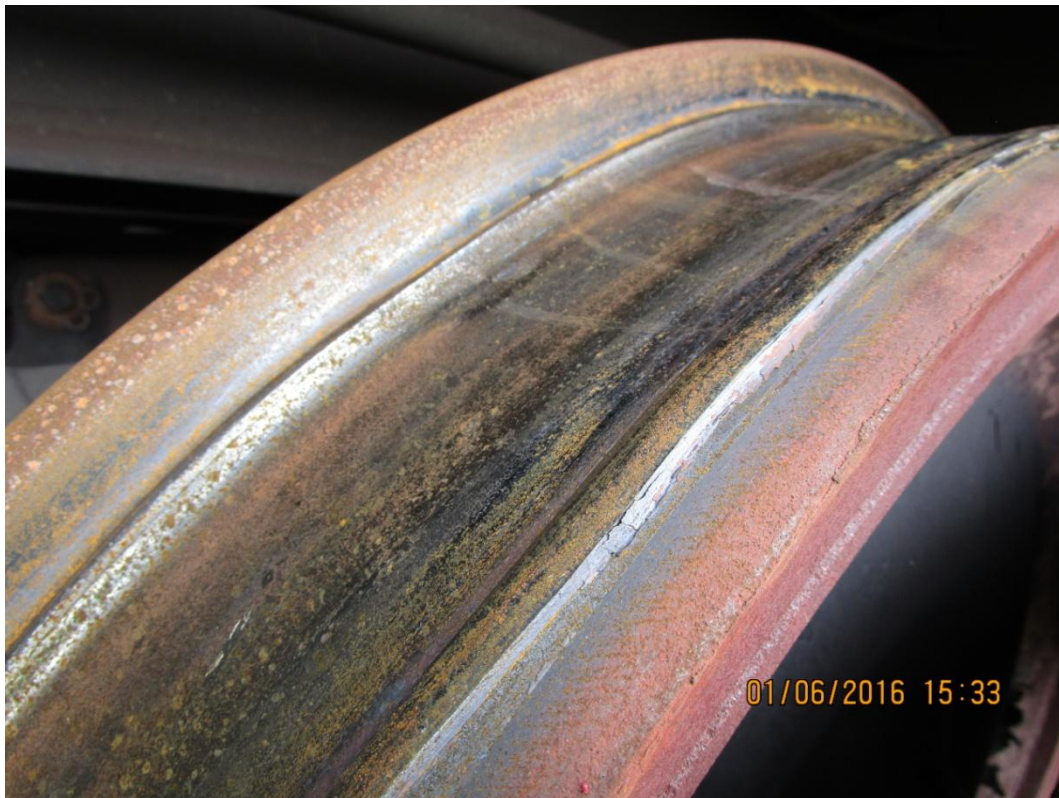
On May 27, 2016, a freight train carrying twenty cars with LPG had a fixed break near Breda (NL). Research shows that due to the fixed/sliding brake in one car the temperature of the wheels and brake blocks has been such that all brake blocks of this car were burned and the tread of the wheels in question is deformed. That created a serious risk of derailment. This damage has occurred in a relatively short period of time. Respondents report fire hazards to the wheels of the car in question, probably within six kilometers after the fixed brake was formed. In addition, the car is not derailed and no damage has been caused outside the destructive damage to the wheels and brake pads. The last hotbox measuring point is about twenty kilometers from the point where the train has come to a halt. This last measurement has not measured a sliding/fixed brake.

Despite extensive research by ProRail, Captrain Nederland BV and ILT, the cause of the sliding/fixed brake has not become clear. Research shows that the brake in question was fitted with composite brake blocks, type LL. This specific type of composite brake blocks are European approved and replace since 2008 the cast iron

brake blocks. In cast iron brake blocks, the heat generated can be absorbed by the wheel and the cast iron brake block in case of inhibition. Composite brake blocks do not conduct the heat, which means that all heat must be absorbed by the wheel. In the Netherlands we are not familiar with earlier similar incidents. However in September 2017 a similar incident occurred in the south of The Netherlands.

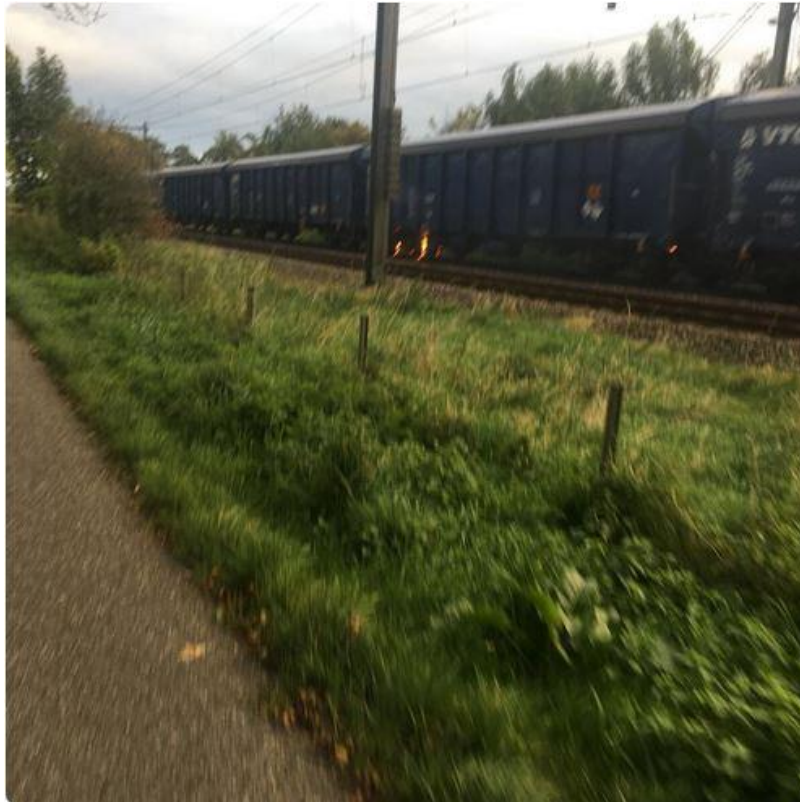
Composite brake blocks on fire (sept 2017)
